**Historic Preservation Review Commission**

- **COA-Storefront windows at 1600 Miner Street**

**Preliminary Review-Rehabilitation of 1601 Colorado Blvd.**

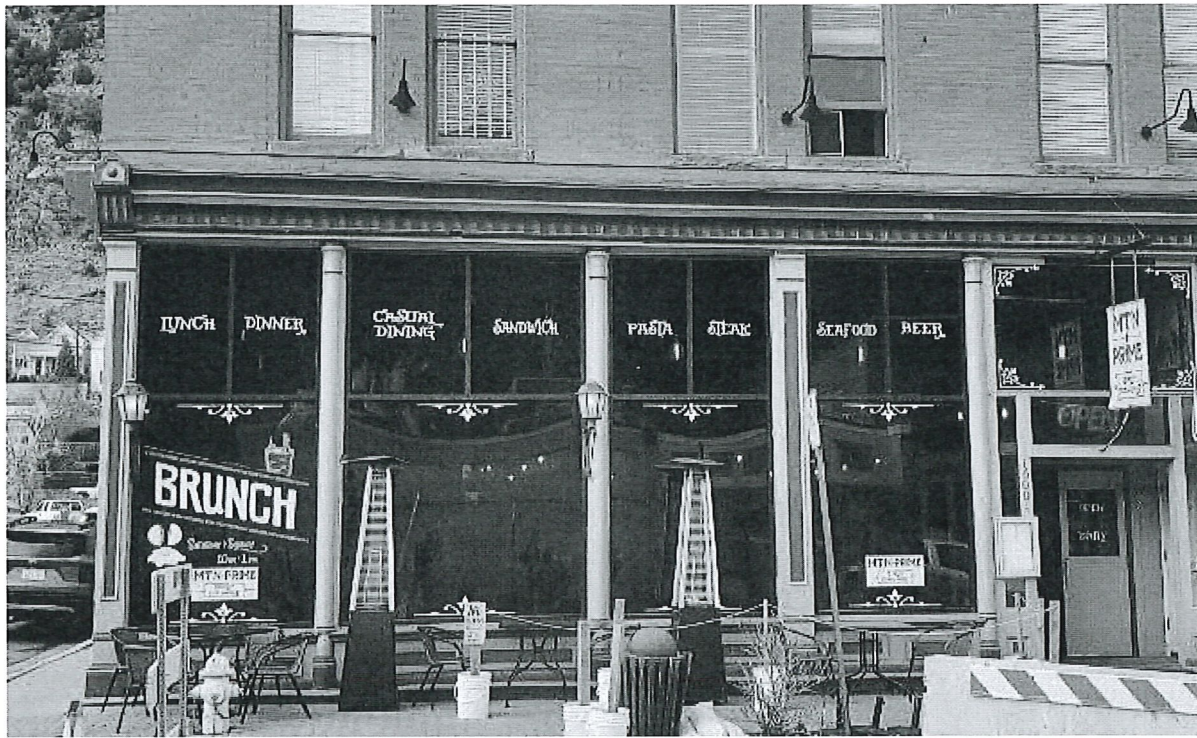
Existing storefront

The Applicant proposes replacing the four large storefront windows with a sectional roll up windows. The Mock-up below labels these windows as A, B, C, and D. The "shop drawing" that follows the mock-up provides a more detailed drawing of one of the proposed windows. From what was originally discussed, the Applicant made changes so that the proposed framing (stiles and rails) of the window panes would be more compatible in appearance with the historic character of the Downtown District.

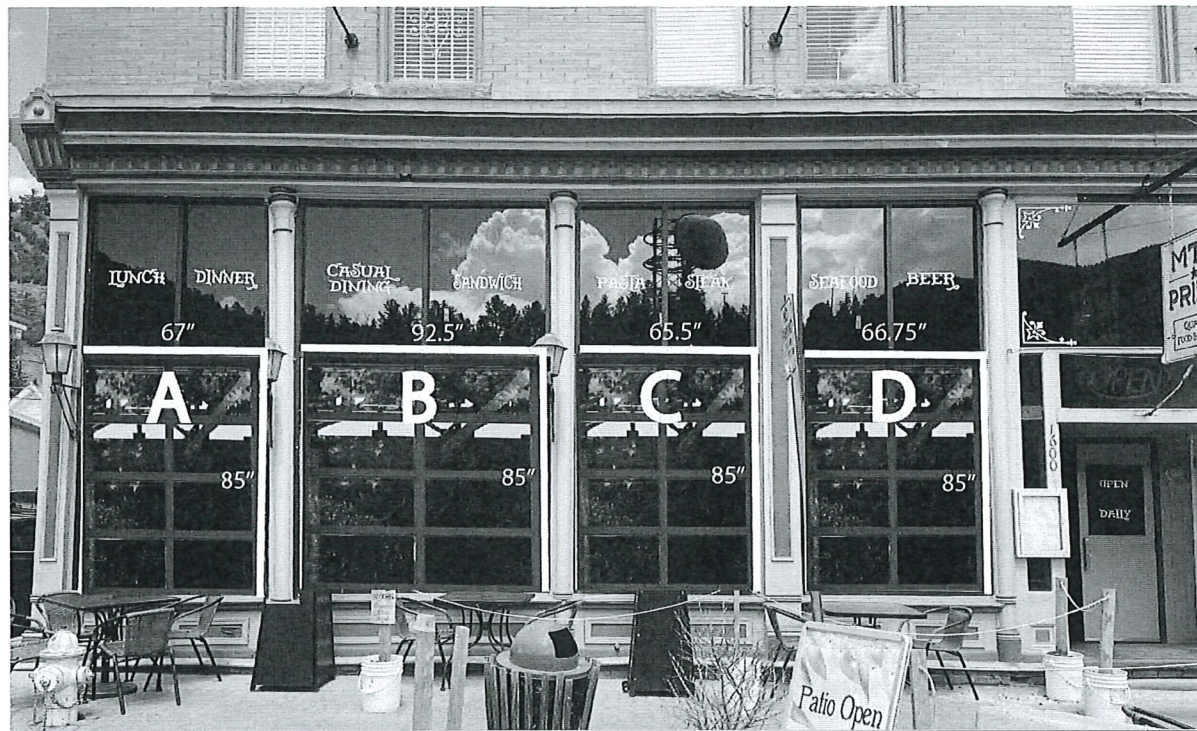
Applicant's Mock-up of the proposed alteration to the facade

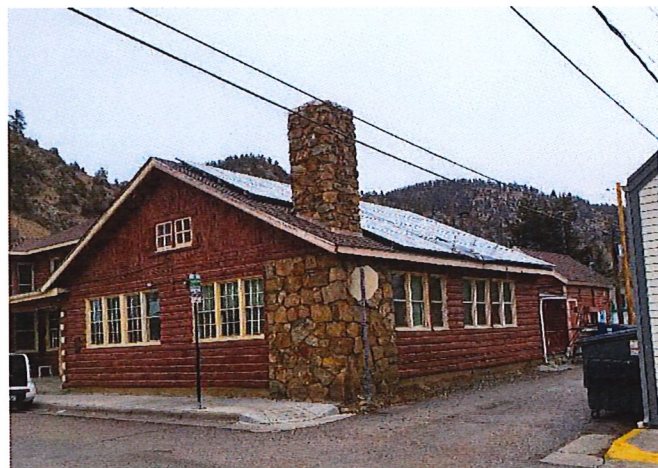
*View along east side property line  
Hi Lana,*
